# ASSESSMENT OF PUBLIC TOILETS IN THIMPHU 2025

A CASE STUDY REPORT

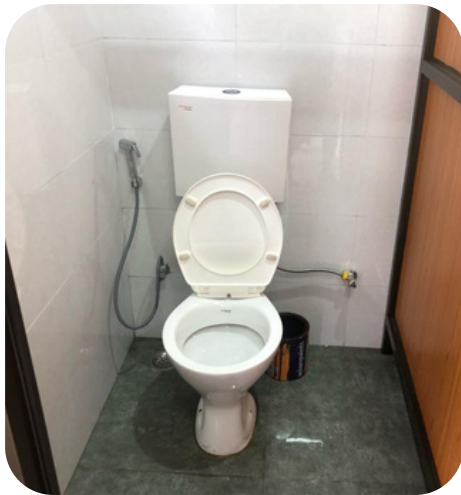
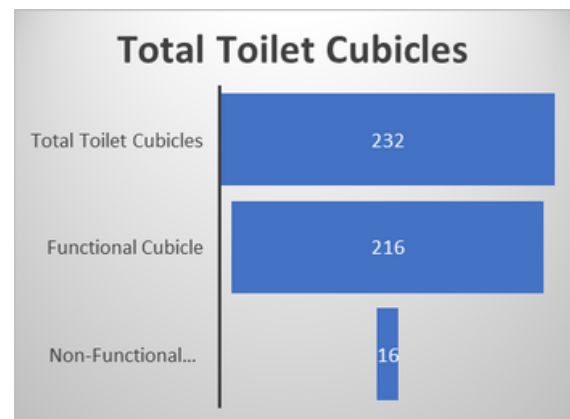
Figure 4. Number of functional and non-functional toilet cubicles

The assessment recorded the total of 100 toilet cubicles and 64 urinals for male and 115 toilet cubicles for female. It was found that 16 toilet cubicles are non-functional due to blockage and lack of continues running water.

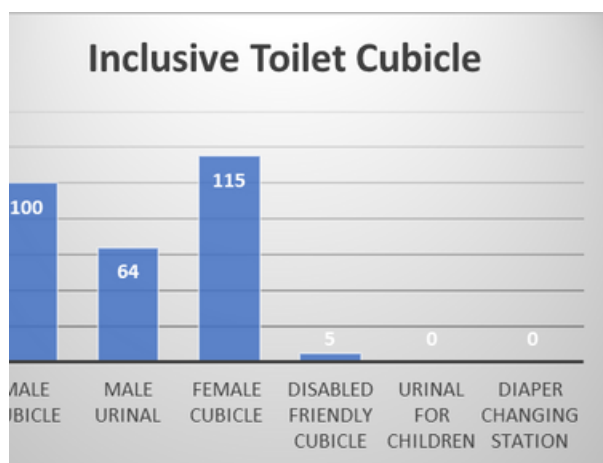
Figure 14. Disabled friendly public toilets

The accessibility features for vulnerable social groups were assessed in all toilet cubicles. While there are an adequate number of toilet cubicles and urinals for general users, only five cubicles were found to be user-friendly for Persons with Disabilities (PwDs). Additionally, none of the public toilets had child-friendly toilet pans or urinals. Similarly, no diaper changing stations or baby-holding features were found in any of the facilities.

- Convert at least one toilet cubicle into a disabled friendly toilet in all public toilets
- At least install one urinal for children in all public toilets
- Feature such as grab bar, ramp, door size, tactiles needs to considered.
- Baby holder and diaper changing station is recommended in priority area toilets

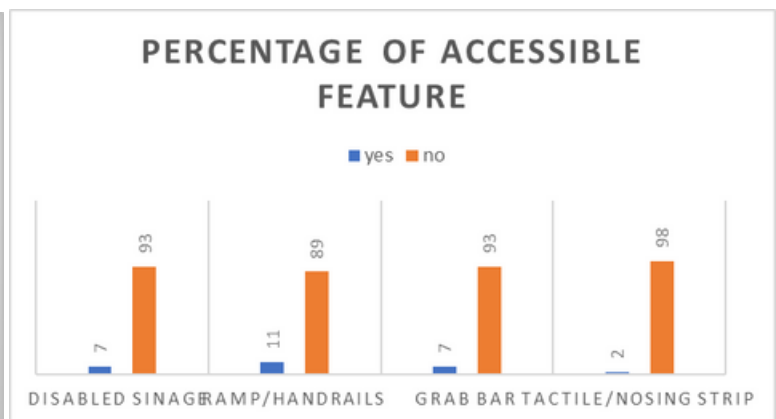
Figure 16. Accessible features in public toilets

In terms of accessibility features such as ramps, grab bars, and tactile indicators, the majority of public toilets lacked these essential elements. About 93% of public toilets did not have signage for Persons with Disabilities. Only 11% of public toilets had handrails to support senior citizens and individuals with physical disabilities. Furthermore, 93% of toilets lacked grab bars within the cubicles, and 98% had no tactile guides for visually impaired users.

Accessibility features were found to be severely lacking in most public toilets, clearly affecting vulnerable social groups. There is an urgent need to prioritize the development of inclusive and accessible public toilets for all.
